**Docket No. 217 – Development and Management Plan Inspection**

Northeast Utilities Service Company Certificate of Environmental Compatibility and Public Need for the construction of a 345-kV electric transmission line and reconstruction of an existing 115-kV electric transmission line between Connecticut Light and Power Company's Plumtree Substation in Bethel, through the towns of Redding, Weston, and Wilton, and to the Norwalk Substation in Norwalk, Connecticut.

**Date:** May 10, 2006

**Location:** 345kV Underground Route

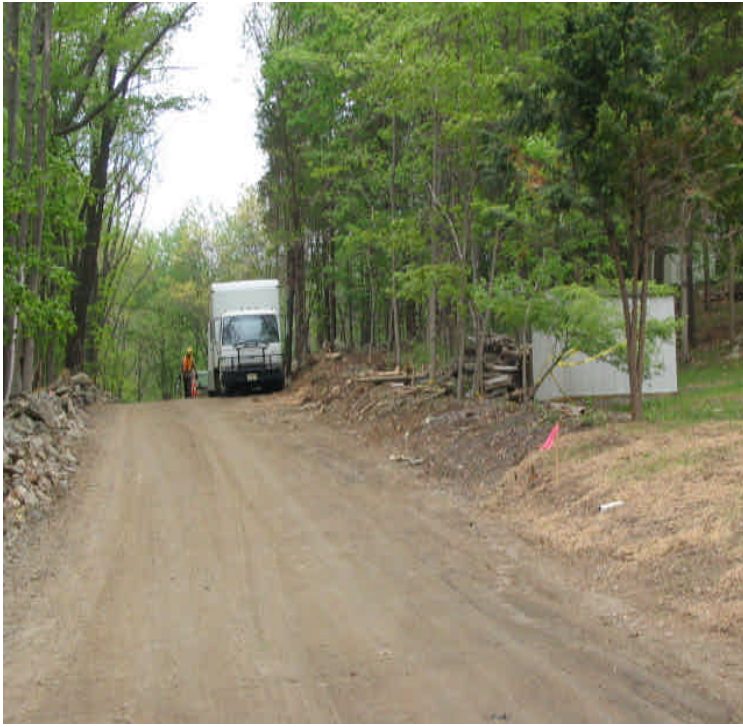
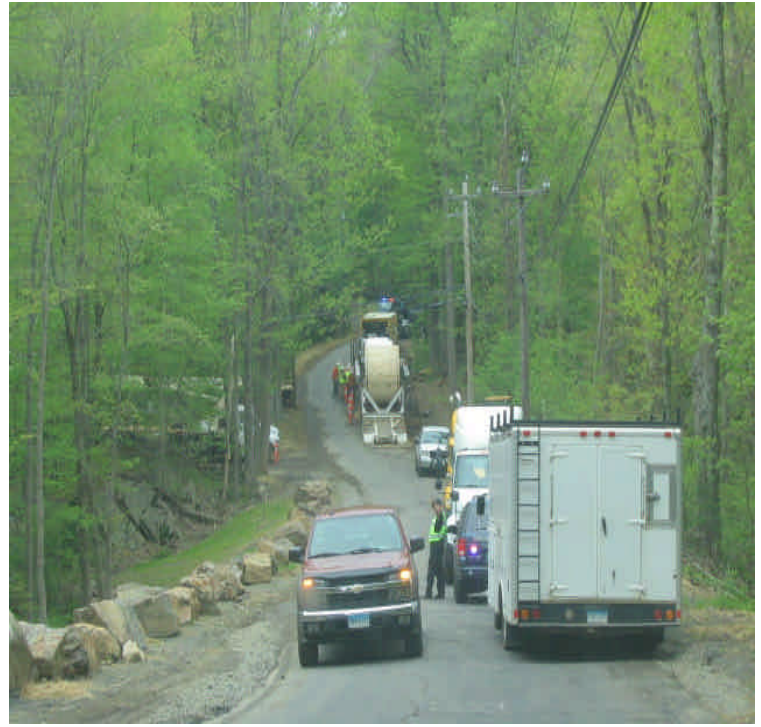
**345kV (Archers Lane, Umpawaug Rd) Photo on the left shows active work returning along the AL access drive. Photo on the right shows work along Umpawaug Rd. internal to the vaults and trench.  
5/10/06**

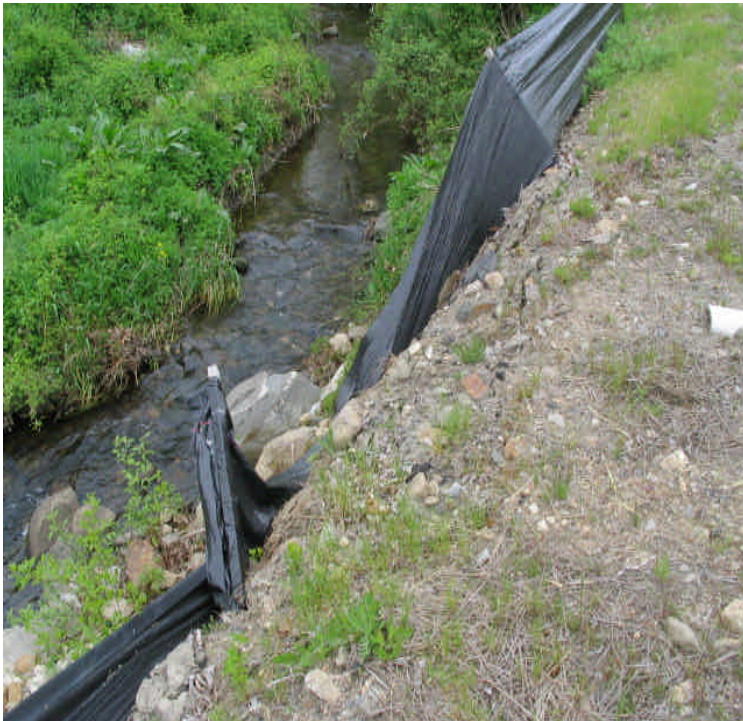
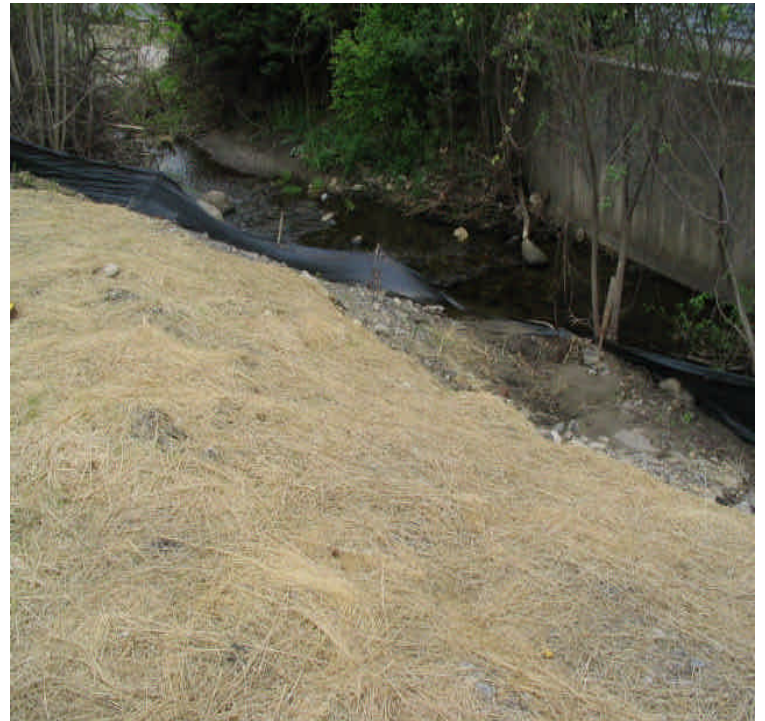
**(Georgetown Deli): Photo on the left shows where a section of bank is eroding north of the plaza driveway. Rocks will be placed here in an effort to stabilize. Photo on the right shows where the recent rains had caused a washout along the stream bank. Soils here are too sandy for quick vegetative growth so mats will be installed. 5/10/06**

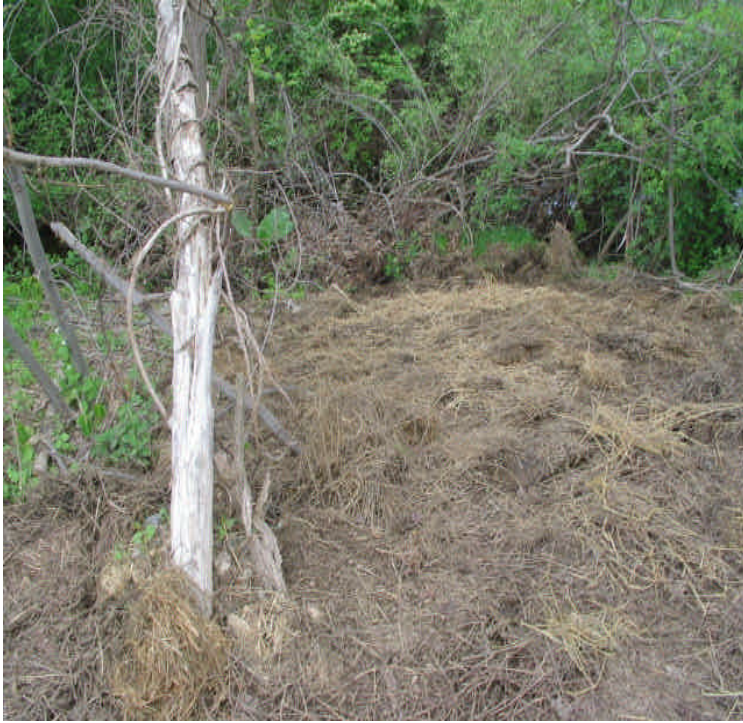
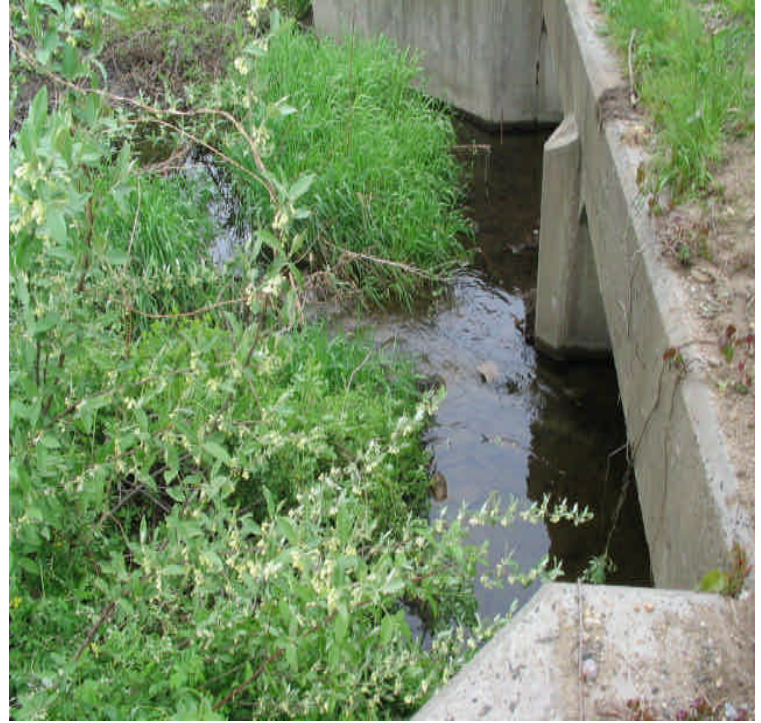
Photo on the left shows where stone from the old basin outlet was removed and the bank of the stream was restored. Photo on the right shows where the old instream controls were removed.  
5/10/06

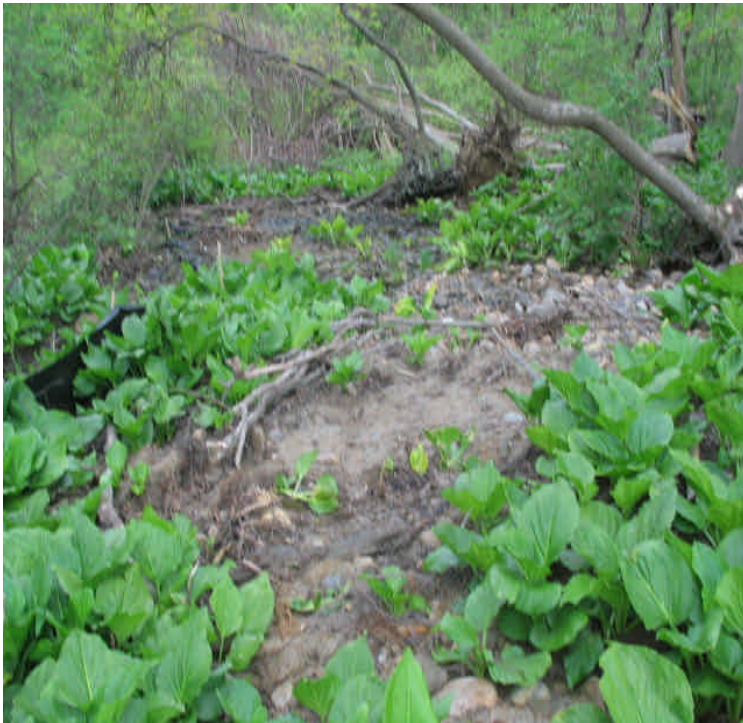
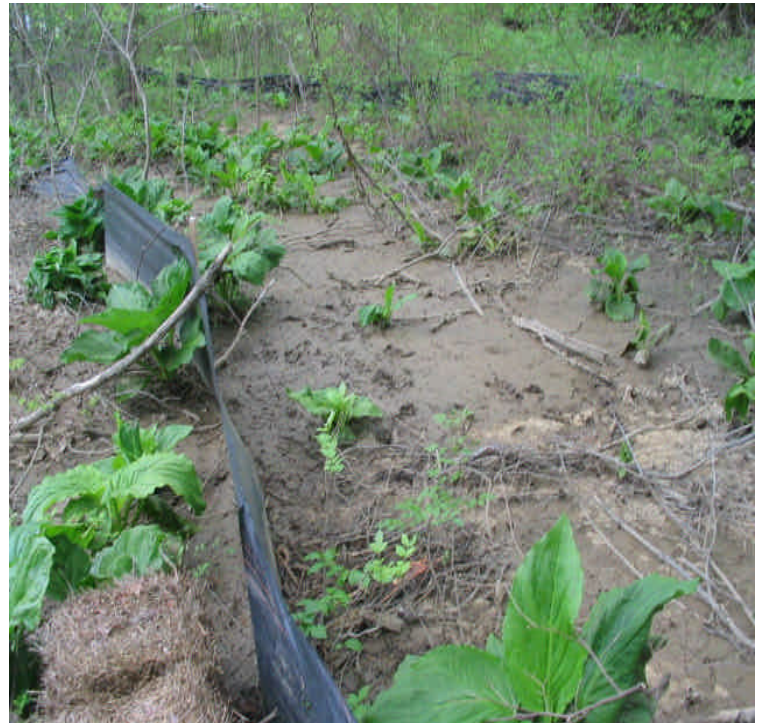
Photo on the left shows the accumulated sediment in the wetland beyond the basin. Crews will be removing sediment deposits carefully by hand. Photo on the right shows the area of sediment accumulation east of the basin. Crews will also be working here to remove sediment. 5/10/06

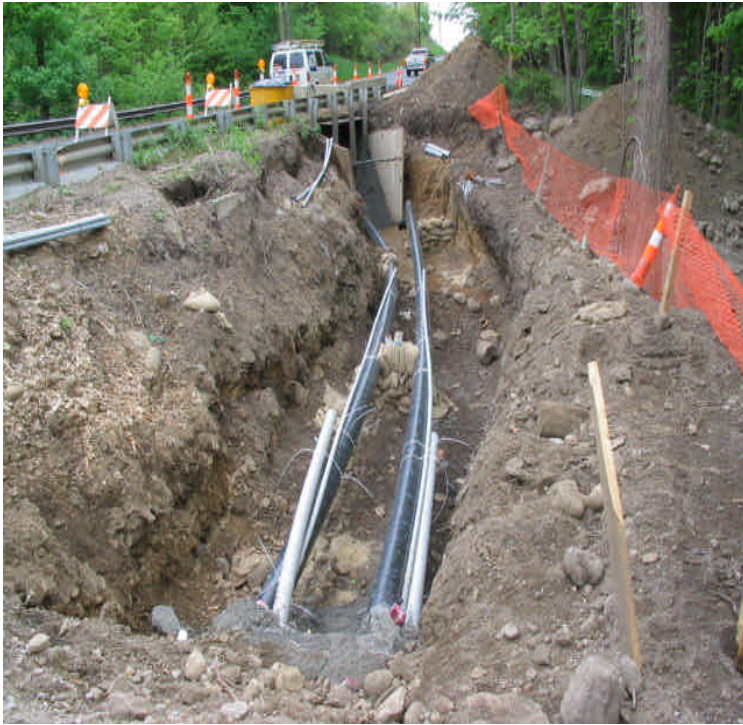
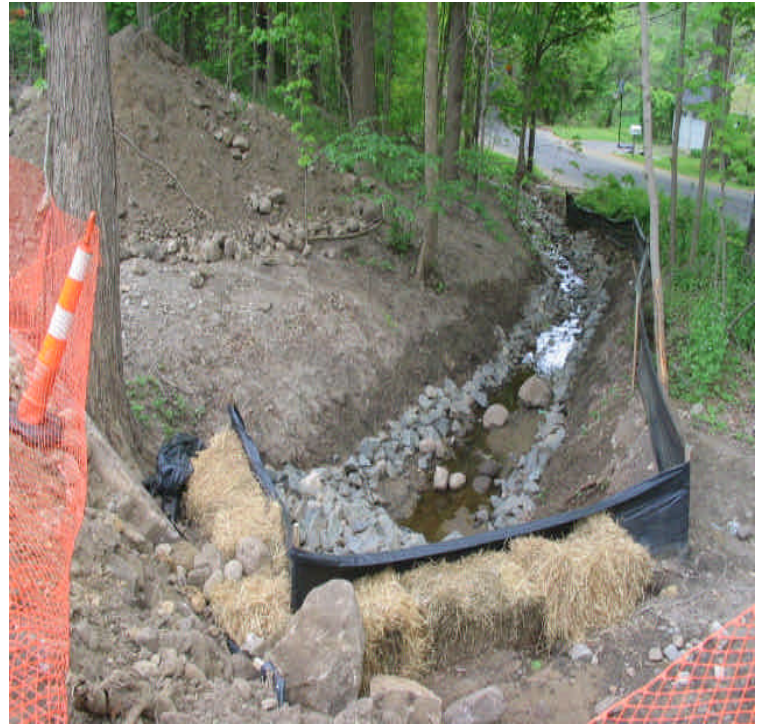
Photo on the left shows an area of active work near Old Danbury Rd. Photo on the right shows the recently constructed swale. Adjacent bare slopes had caused some sedimentation to the swale. Stockpiles should also be stabilized temporarily. 5/10/06

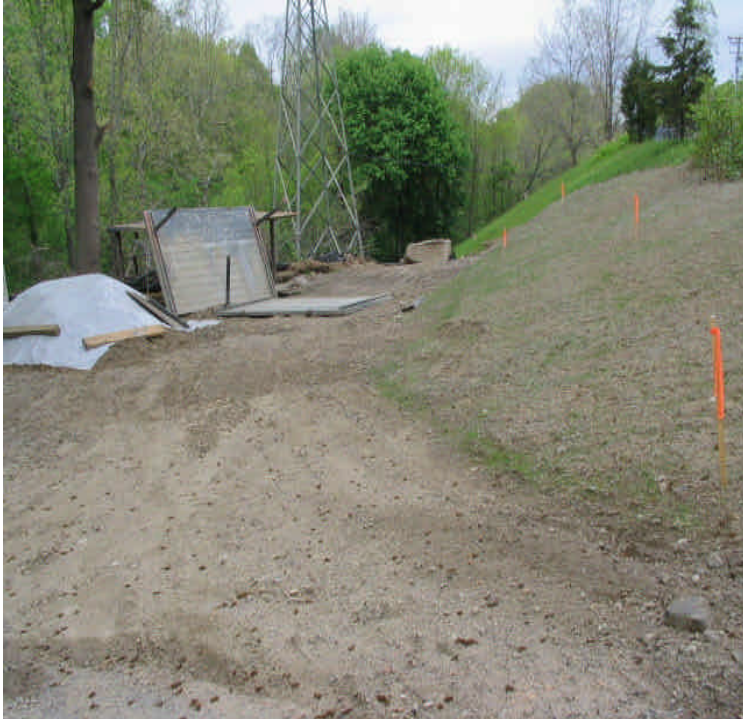
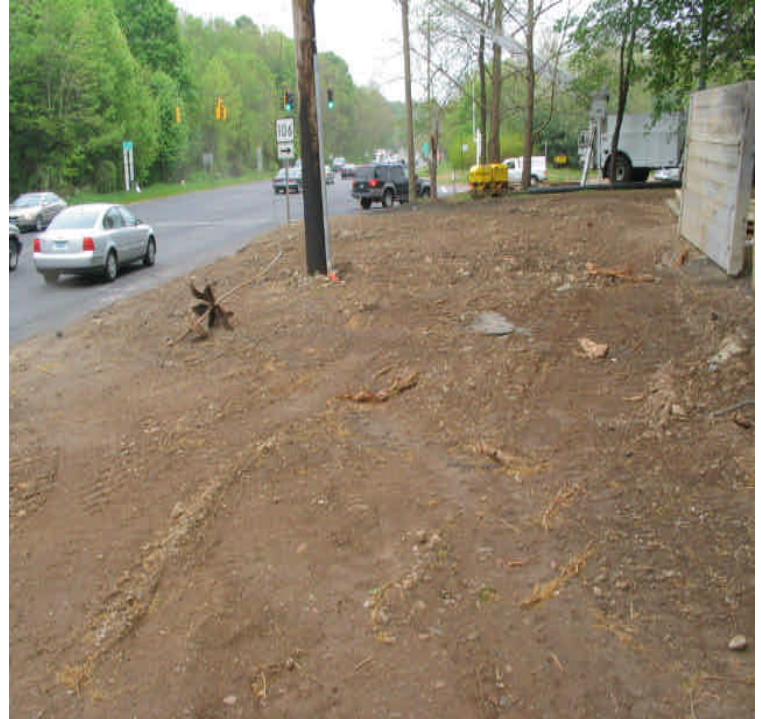
Photo on the left shows good restoration efforts along the bank near the HDD exit point. Some additional restoration will be needed right at the exit point. Photo on the right shows where the open vault near the Wilton Corp. Park was backfilled. 5/10/06
